**NAVAL AVIATION SAFETY CENTER**

1. F-4B BuNo 148426 sustained overheat (Bravo) damage when the R/H main landing gear (MLG) collapsed and the airplane settled on the R/H external drop tank during arrestment.

Damage incurred F-4B (F4H-1) BuNo 148426 due to hard landing  
aboard USS Forrestal

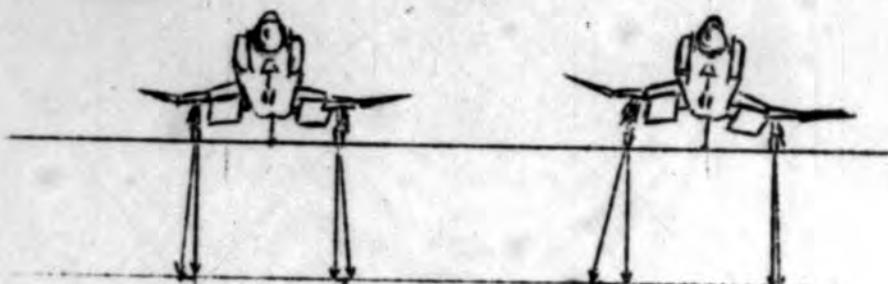
SKETCH DEPICTING INCREASED MLG SIDE LOADS DUE ROLL AND ROCK TOUCHDOWN

4. The landing under discussion provided the side loads required to render the fracture complete. The airplane landed in a left side slip which imposed a side vector force working against the R/H side brace actuator. This force was the result of the action of the R/H main mount dragging as it contacted the deck opposed to the direction of airplane travel. The previously discussed side vector force felt as the airplane rocked onto the R/H main mount after initially touching down left mount first added another side load. These additive side loads aggravated by the fact that the airplane was slightly fast, riding slightly high on glide slope and just very slightly left of center accelerated failure of the part which had been materially weakened by the recorded hard landings.

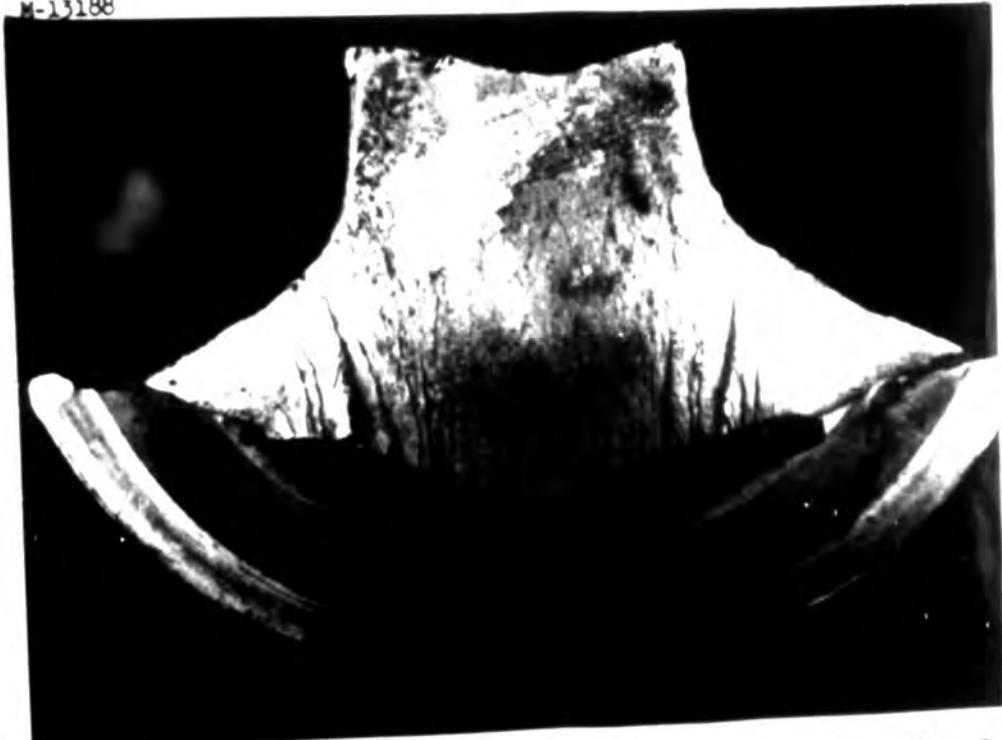
FIGURE 2 - FRACTURE SURFACES OF LOWER END FITTING

2. The R/H side brace lower end fitting (P/N 32-41613-1) was broken in half through the eye (enclosures (12) (13) and (14)). The R/H MLG was broken off at the aft trunnion (P/N 32-41626-4) just forward of the attach point for the aft drag brace cylinder (enclosure (15)).

16. The MLG side brace actuator end fitting failed at the eye in primarily a tension loading. The half of the eye which attaches to the MLG strut was the only debris not recovered.
